PROJECT PROFILE

AZALEA REGIONAL SHOPPING CENTER

PROJECT DESCRIPTION

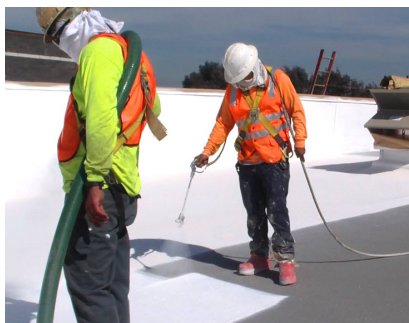
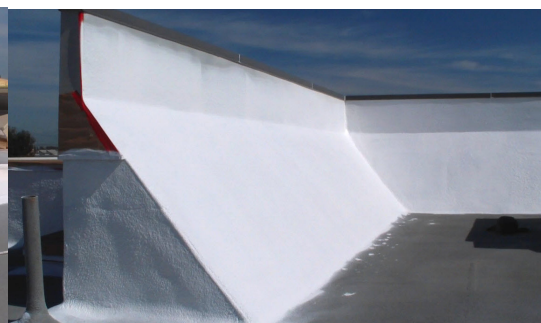
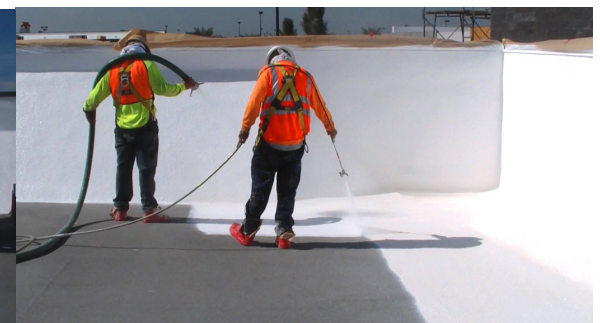
Ari-thane used QUIK-SHIELD® (QS) 2000, a low VOC primer, on the plywood roof decks and QS125 roofing spray foam. To protect foam from UV exposure, a gray base coat of QS1929F acrylic coating was applied. Finally, a white top coat of QS1929F acrylic coating and limestone granules were installed to maximize reflectivity and additionally lower energy costs.

The 10-foot-tall parapet walls created challenges for the applicators. The sections rose at a 45-degree angle from the roof deck for five feet before becoming vertical for the remaining height. The upper section of a 10 foot parapet wall posed significant installation problems for other roofing systems. The versatility of spray foam being able to be applied on the vertical surfaces readily addressed that issue and completely sealed the transition area from the walls to roof seamlessly. The ease of application was another reason to specify spray foam roofing.
